**Final Report for Failure Analysis
of 1U52295-03 RSRM Safety and Arming
Device S/N 0000016**

13 November 1989

**NATIONAL AERONAUTICS AND SPACE ADMINISTRATION
GEORGE C. MARSHALL SPACE FLIGHT CENTER
MARSHALL SPACE FLIGHT CENTER, ALABAMA 35812
NAS8-30490**

***Thiokol* CORPORATION
SPACE OPERATIONS**

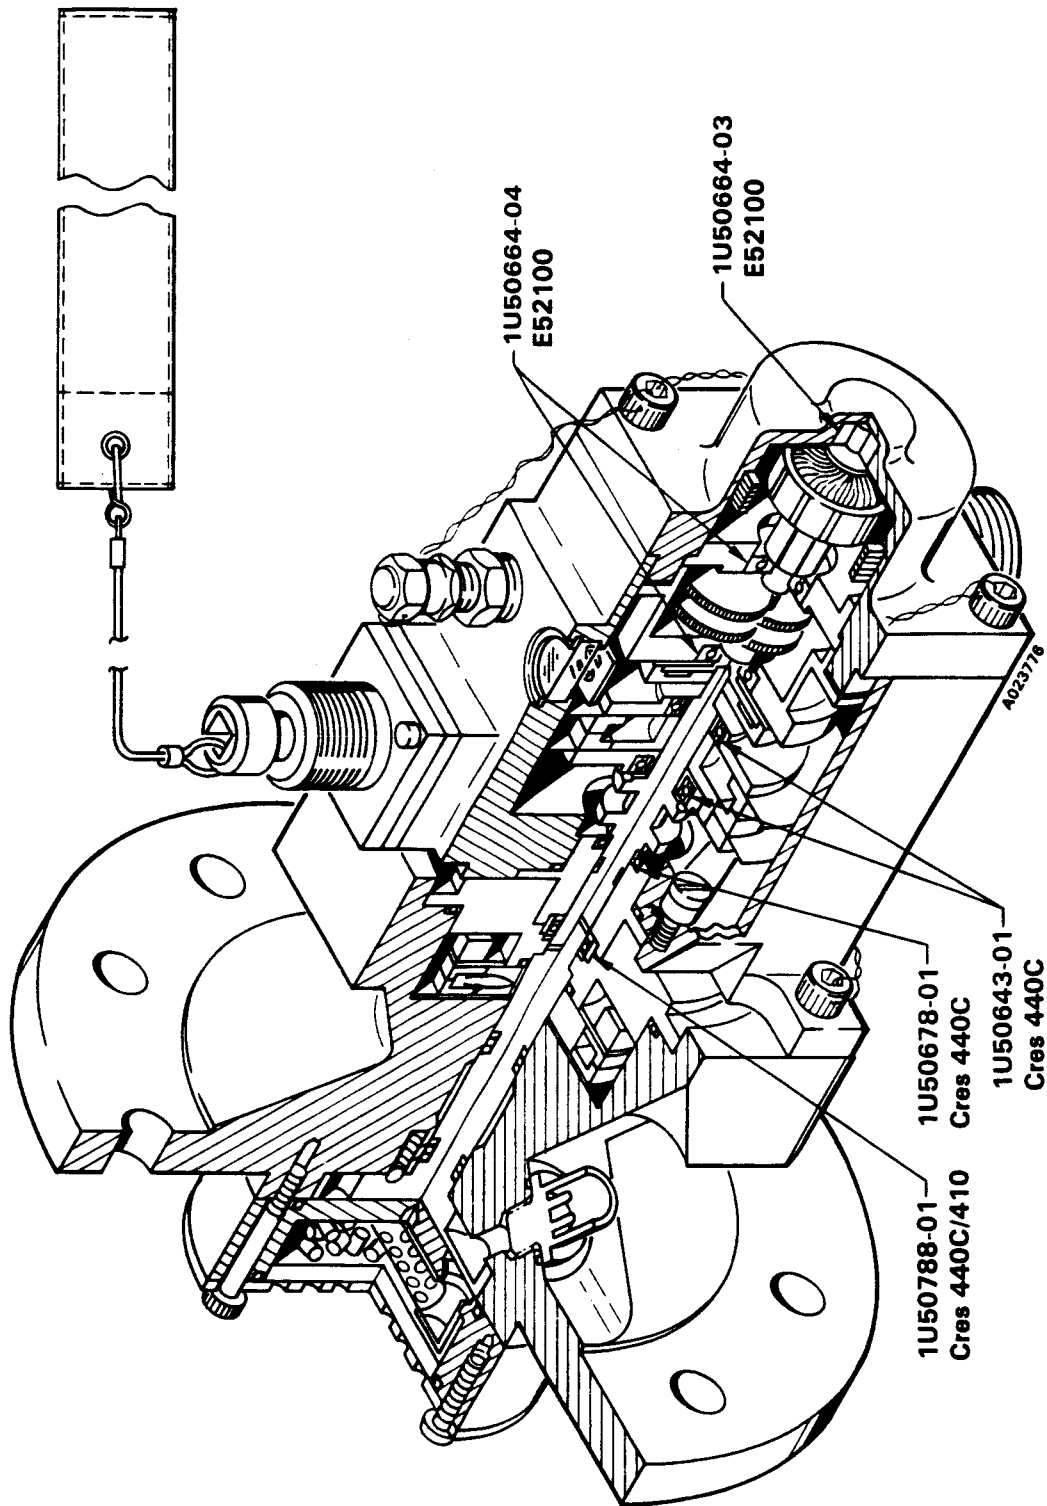
Figure 1
A-M and B-B Bearings

The Arming-Monitor assembly was disassembled with the team members present and looking for any signs of anomalies or malfunctions. As the unit was disassembled, each component was inspected for signs of damage. The only part which showed any discrepancies was the 1U50664-03 upper motor armature bearing (which is located at the very top of the Arming-Monitor, see Figure 1). The bearing could be turned, but felt very rough. Because this is a shielded bearing, a visual inspection of the balls and races could not be performed. After observing the suspect bearing, the actuator assembly was reassembled without the assembly screws torqued to final torque, and the motor ran freely. When the assembly screws were torqued to seating torque, the motor would not function. A replacement bearing was installed in the unit, and the motor performed well when the assembly screws were tightened. The cycle times also improved with the new bearing, and the minimum cycle voltage dropped almost 10 VDC.

The cause of the failure of the S&A to operate was the corroded 1U50664-03 bearing found in the Arming-Monitor assembly. During refurbishment, the bearing had been replaced, and the minimum cycle voltage increased nearly 10 VDC, and the cycle times also increased from 760 milliseconds to almost 900 milliseconds. The unit went through one use and then another refurbishment before the problem was noticed. The history of other Arming-Monitors has been examined for similar increases in cycle times and minimum cycle voltages to detect other bad Arming-Monitors before the problem is duplicated. Figures 2 and 3 show the cycle times and minimum cycle voltages for each serial number at each refurbishment. Several A-Ms, S/N 15, 19, 22, 28, 29, and 41, exhibit characteristics similar to the unit which failed. These A-Ms should be immediately refurbished and have the bearings replaced with new stainless steel bearings.

6.2.1 The non-stainless steel ball bearings (1U50664-03, 1U50664-04) in the Arming-Monitor assembly should be replaced with appropriate bearings made of a suitable stainless steel (440C is the industry standard).

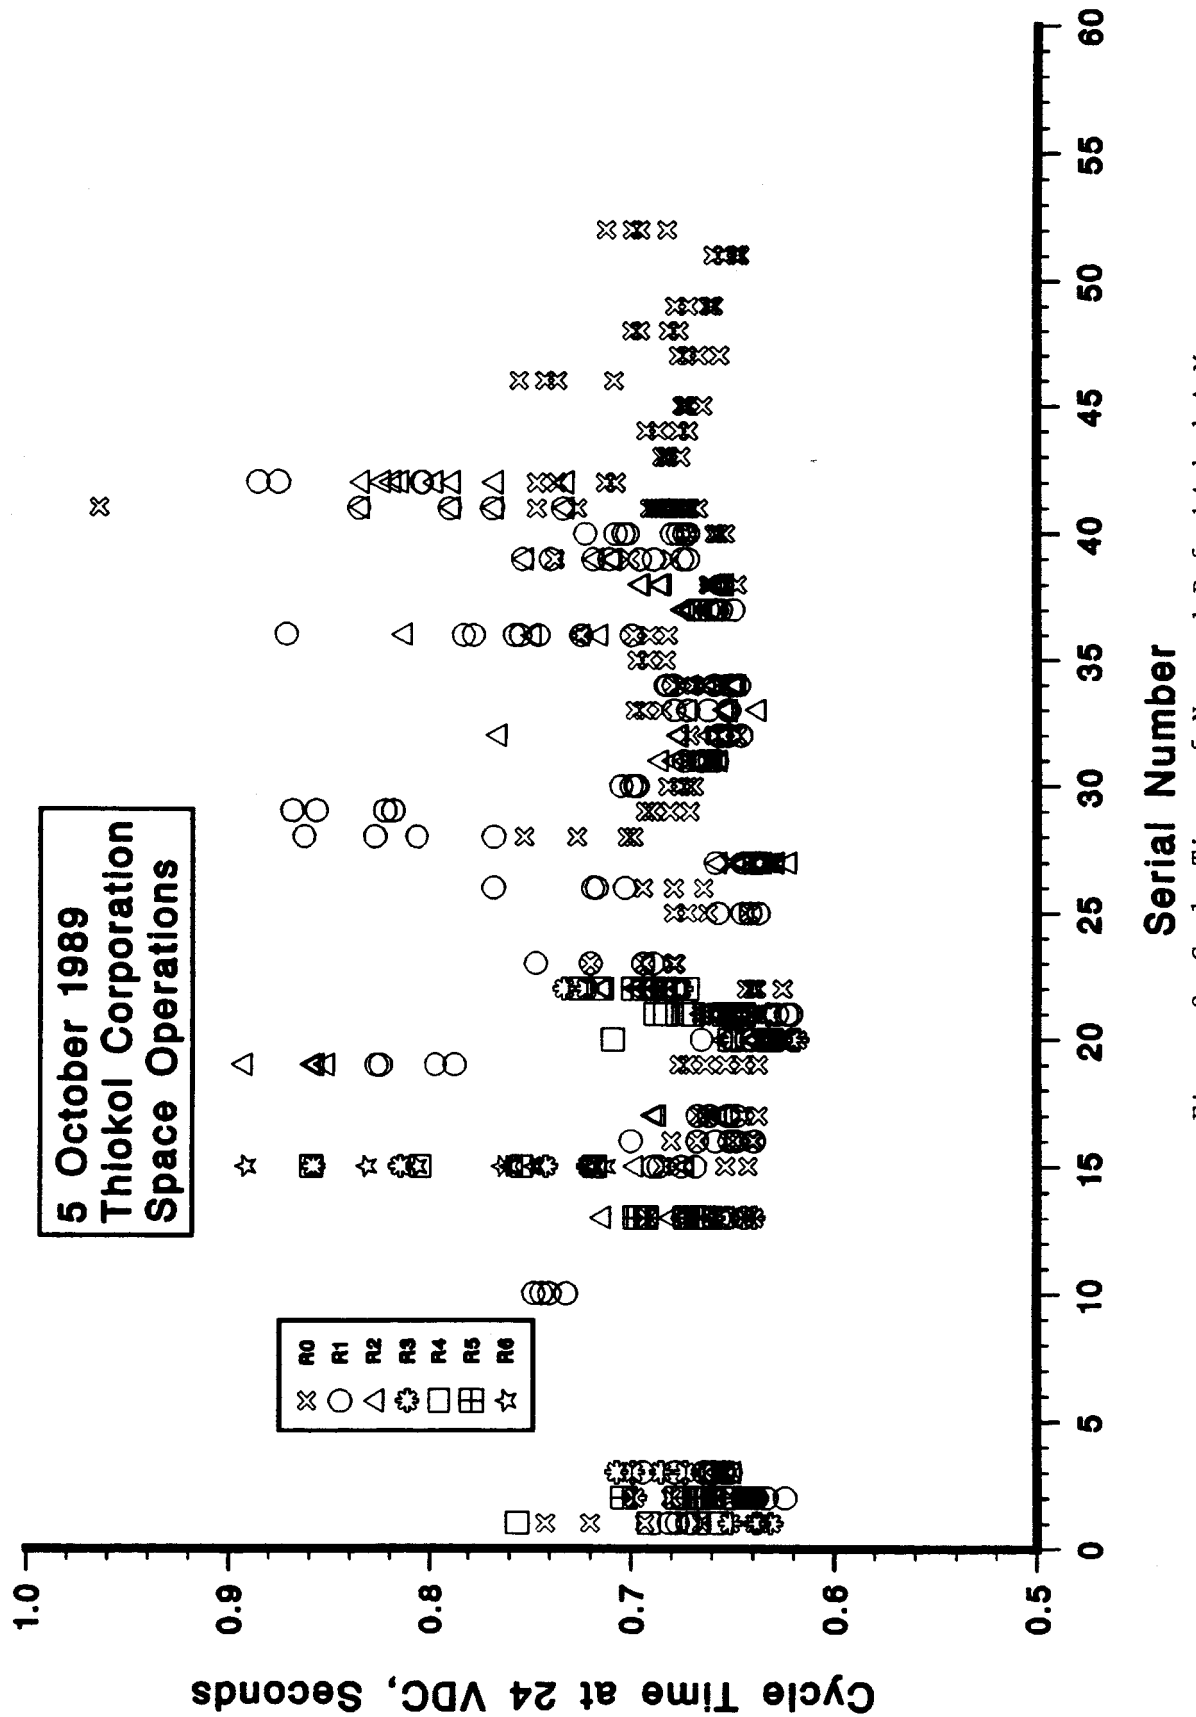
6.2.4 The minimum cycle voltage and cycle times at 24.0 VDC should be re-evaluated for the Arming-Monitor assembly and the subassemblies. The current cycle time limit at 24 VDC for an Arming-Monitor is 1.0 second or less, and the minimum cycle voltage limit is 22 VDC or less. The average cycle time for an A-M is .689 seconds at 24 VDC, and the minimum cycle voltage average is 10.80 VDC. From these figures and the data obtained in this failure investigation, an Arming-Monitor which cycles above 0.8 seconds should be considered suspect. Large jumps in minimum cycle voltage after refurbishment should also flag a unit as suspect. S/N 42 Arming-Monitor experienced a 10 VDC increase in minimum cycle voltage when the bad bearing was inserted during refurbishment, and experienced a corresponding decrease when a good bearing was substituted during the failure investigation.

Figure 2 Cycle Times of New and Refurbished A-Ms

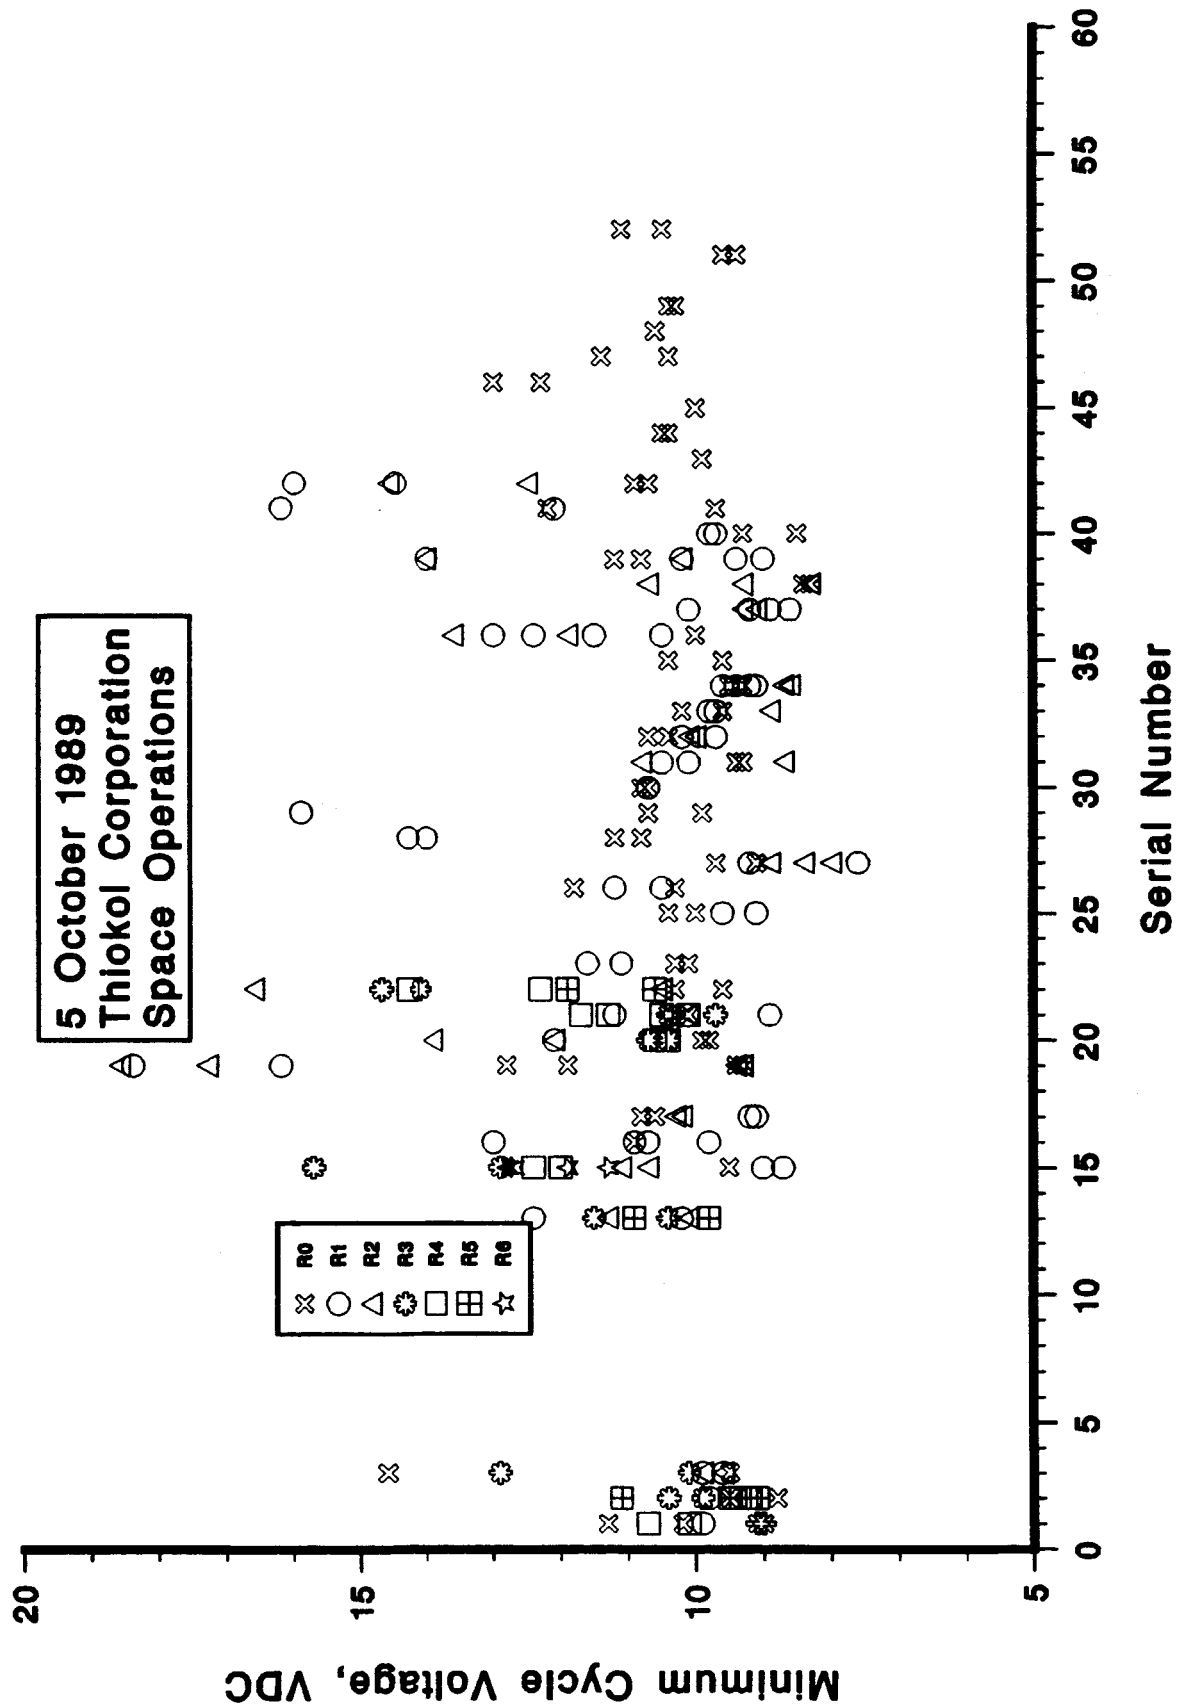
Figure 3 Minimum Cycle Voltage of New and Refurbished A-Ms

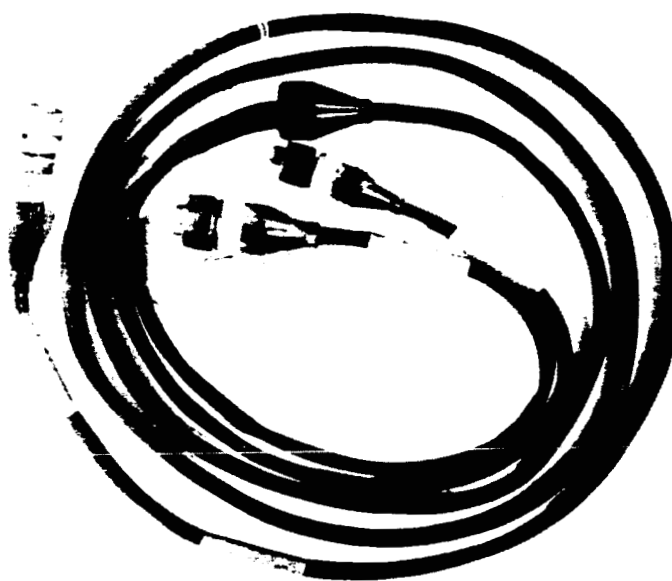
FIGURE 1

- 2.1 A photograph of the cable is shown in Figure 1. Using an ohm meter, the continuity of the cable was completely tested. The intermittent electrical open between pin B of connector JT2 and pins H and J of connector JT1 was confirmed. The electrical resistance of this conduction path was very sensitive to flexing of the cable near connector JT2. Flexing the cable in one direction caused the conductor to open. Flexing the cable in the

PHOTOGRAPH OF THE CABLE IN THE "AS RECEIVED" CONDITION.
MAGNIFICATION: 0.27X

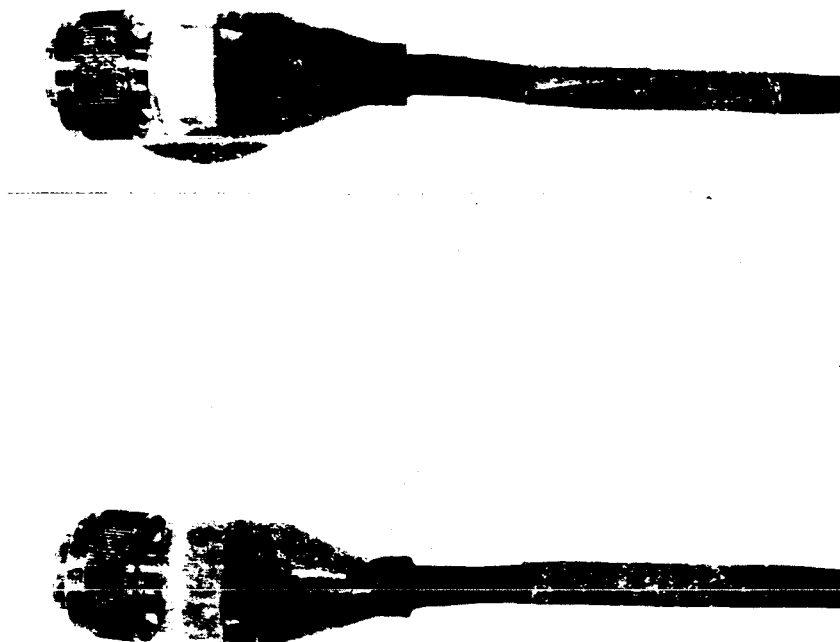
FIGURE 3

PHOTOGRAPHS OF CONNECTOR JT2 AND THE FAULTY PORTION OF THE CABLE.

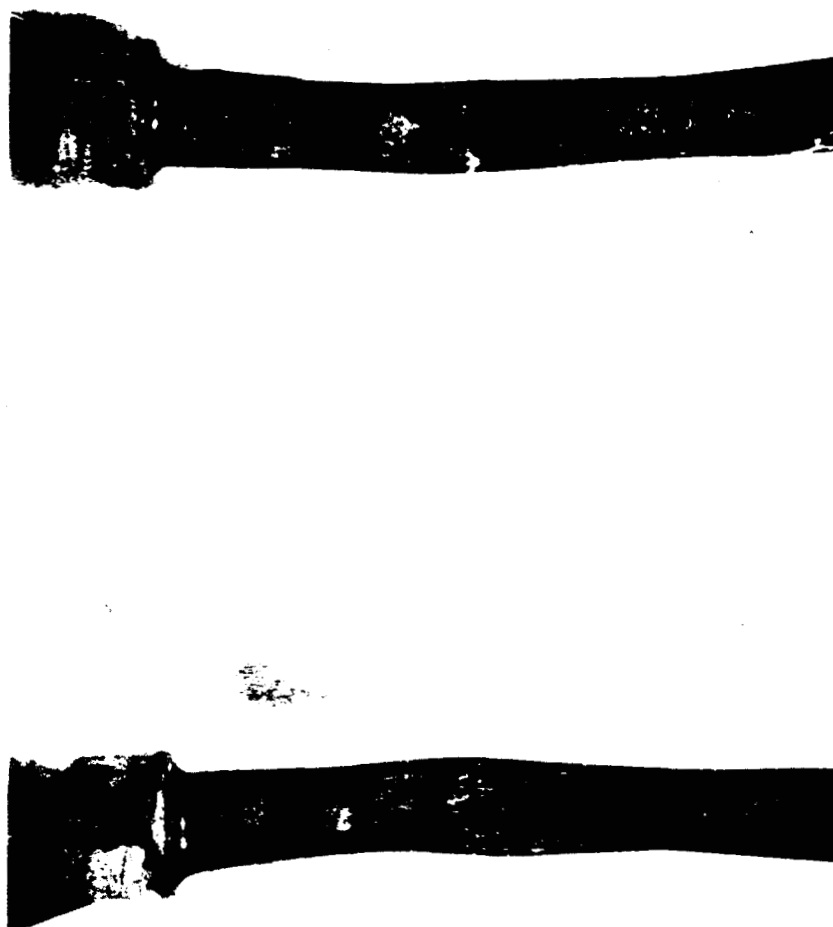
FIGURE 4

PHOTOGRAPHS OF THE FAULTY PORTION OF THE CABLE AFTER THE
CONNECTOR LABEL WAS REMOVED.

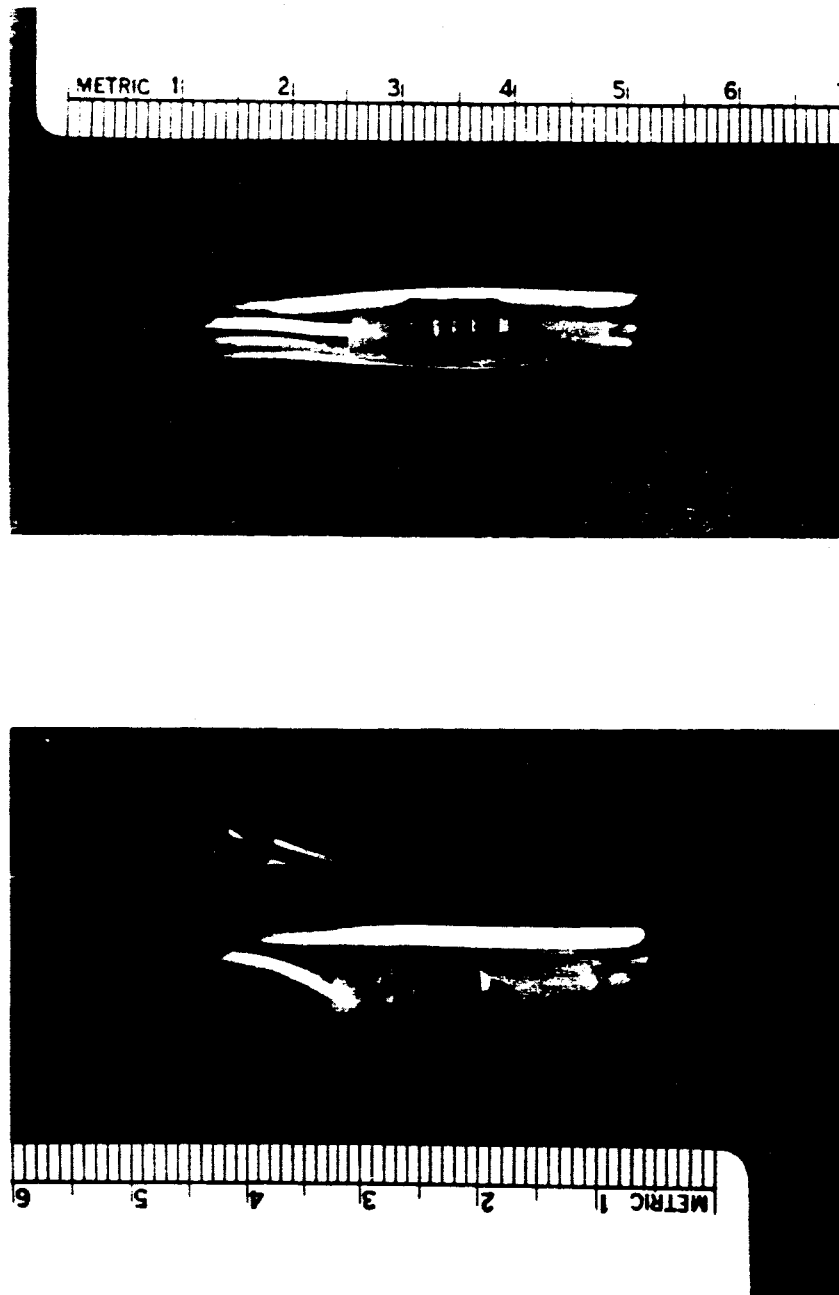
FIGURE 5

PHOTOGRAPHS OF THE FAULTY PORTION OF THE CABLE WITH THE CABLE JACKET OPENED.

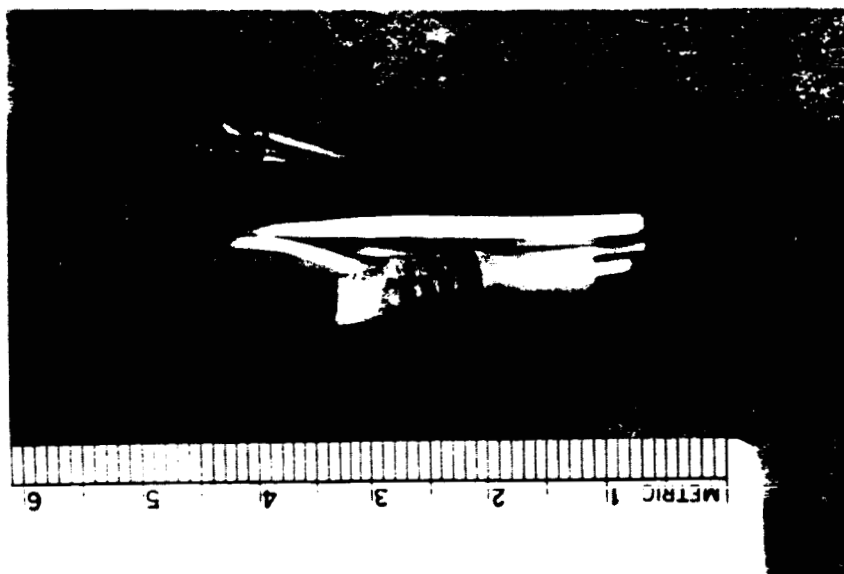
FIGURE 6

PHOTOGRAPH OF THE FAULTY PORTION OF THE CABLE WITH THE FREE
WIRE END OUTSIDE OF THE HEAT SHRINK TUBING.

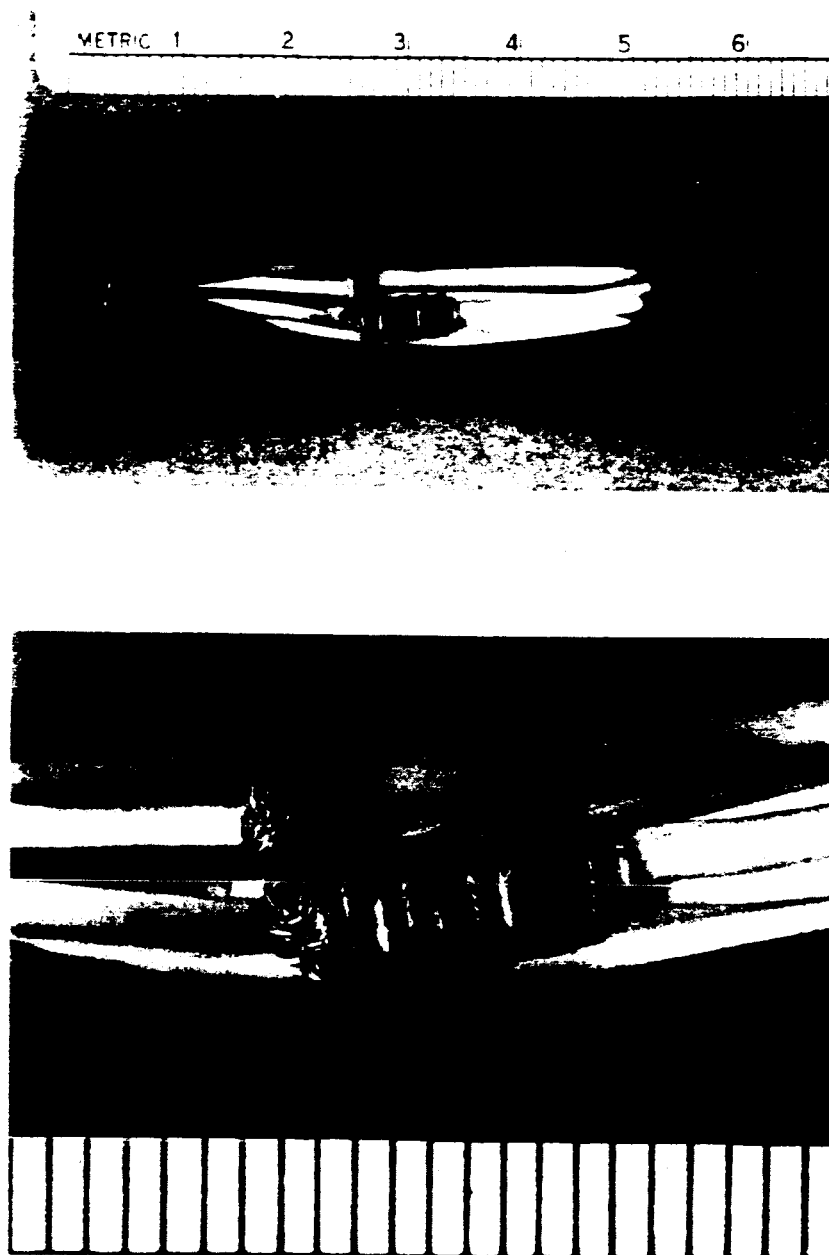
FIGURE 7

- 3.1 The use of crimp connectors in the flexible portion of the cable made the cable very susceptible to continuity failure. Crimp connections are not very tolerant of the frequent flexing and tension to which such test equipment cables are exposed.
- 3.2 The susceptibility of the cable to continuity failure was aggravated by the placement of the crimp connectors near a cable connector. In the case of equipment cables which are frequently connected and disconnected, the portions of the cables nearest the cable connectors usually experience the greatest amounts of flexing stress and pulling.

PHOTOGRAPHS OF THE CRIMP CONNECTOR WITH THE HEAT SHRINK TUBING REMOVED.

It is suggested that consideration be given to redesigning the cable in order to isolate all connections from flexing and tension and/or make connections less prone to failure due to flexing and tension.

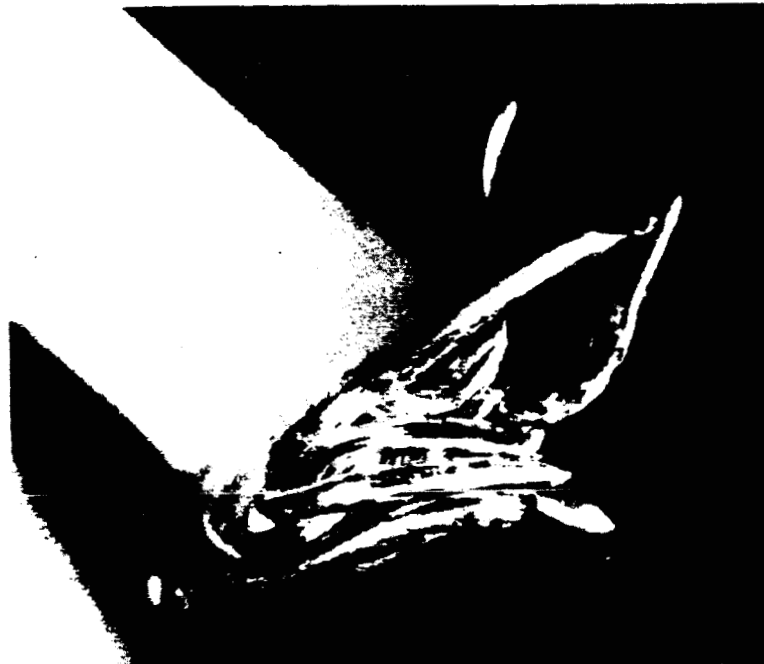
FIGURE 8

PHOTOGRAPH OF THE FREE WIRE END.
MAGNIFICATION: 30X

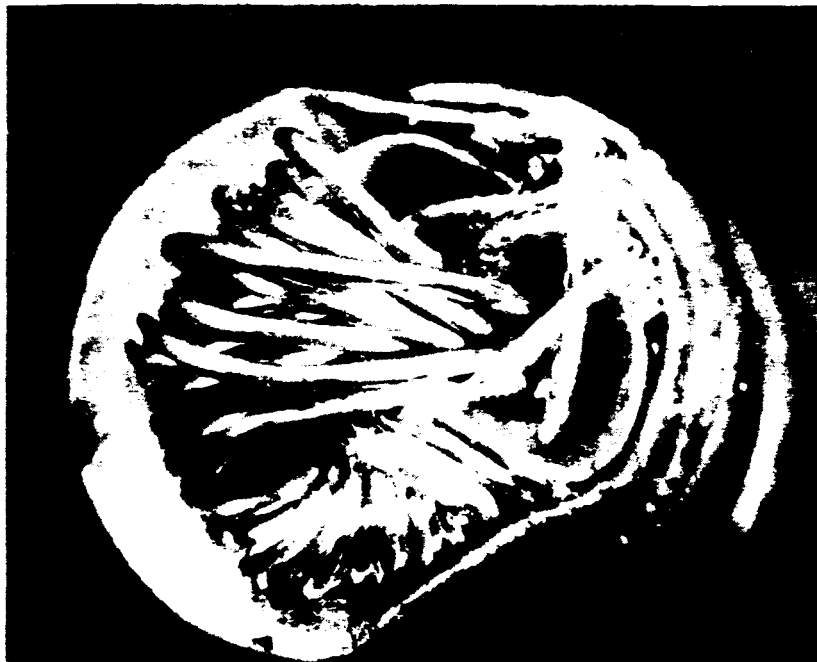
FIGURE 9

PHOTOGRAPH OF THE END OF THE CRIMP CONNECTOR.
